# Town of Middleborough Department of Public Works

## ASSET MANAGEMENT PROGRAM OVERVIEW AND SUMMARY OF FINDINGS

August 25, 2014

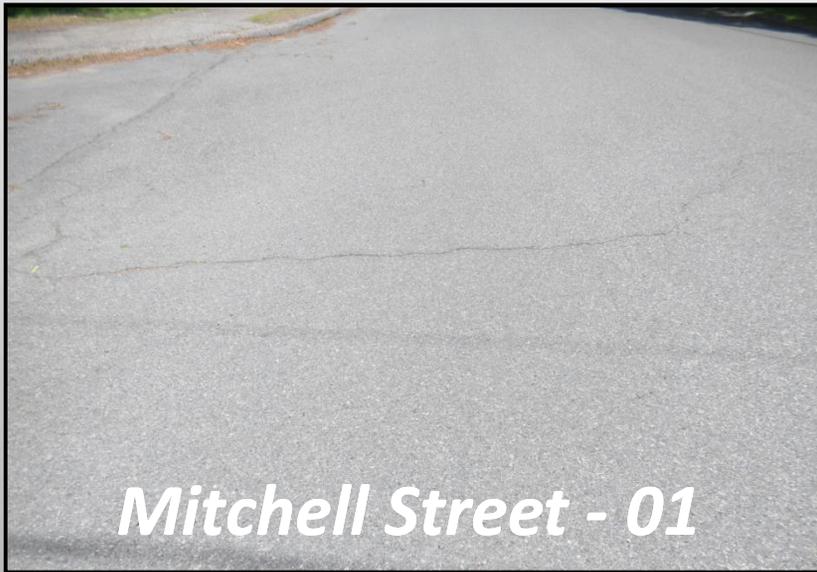
*RSR = 85*

*Grade = B*

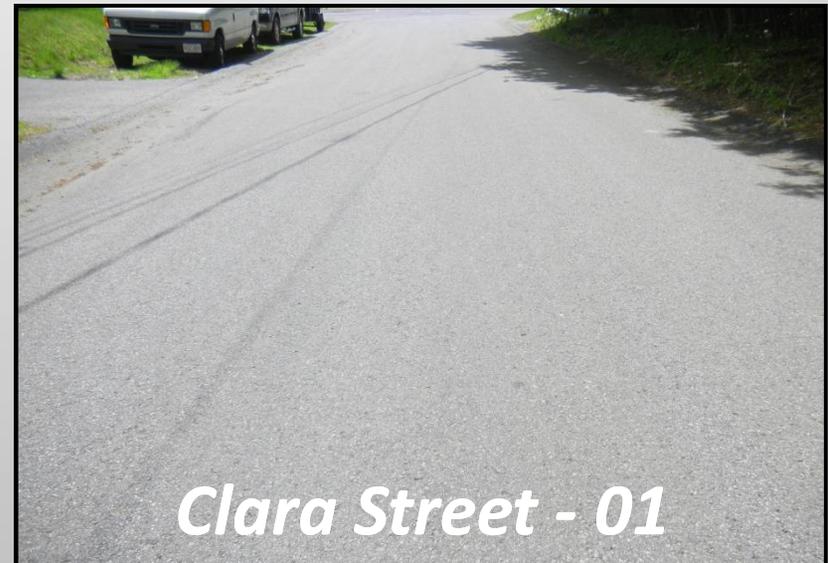
*RSR = 95*

*Grade = A*

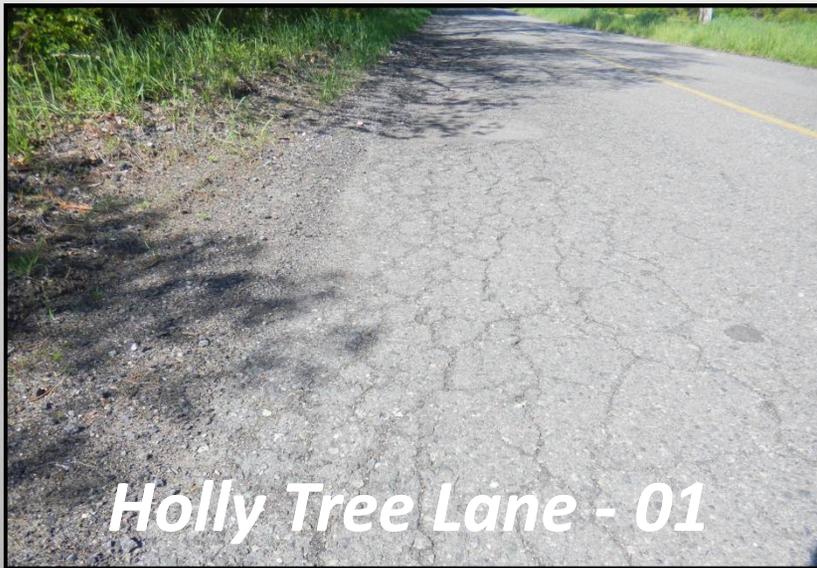
*Holly Tree Lane - 01*

*RSR = 64*

*Grade = D*

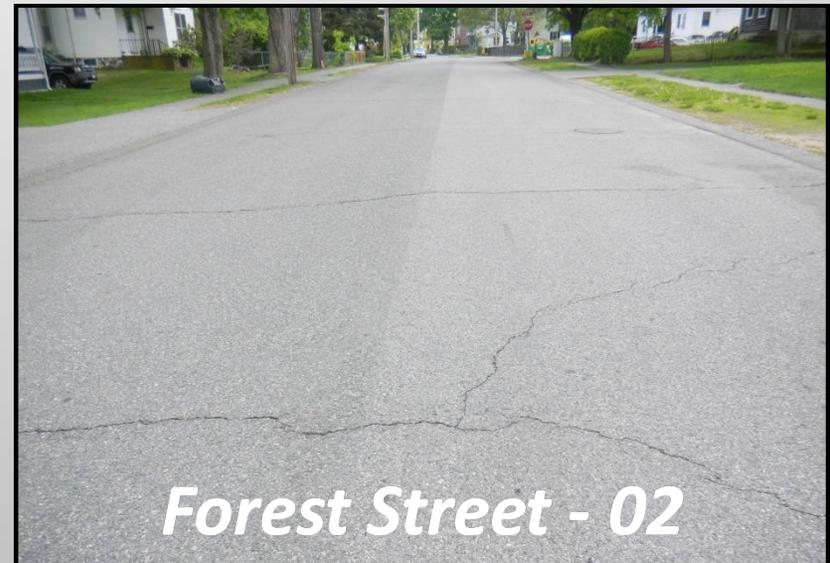
*Forest Street - 02*

*RSR = 80*

*Grade = C*

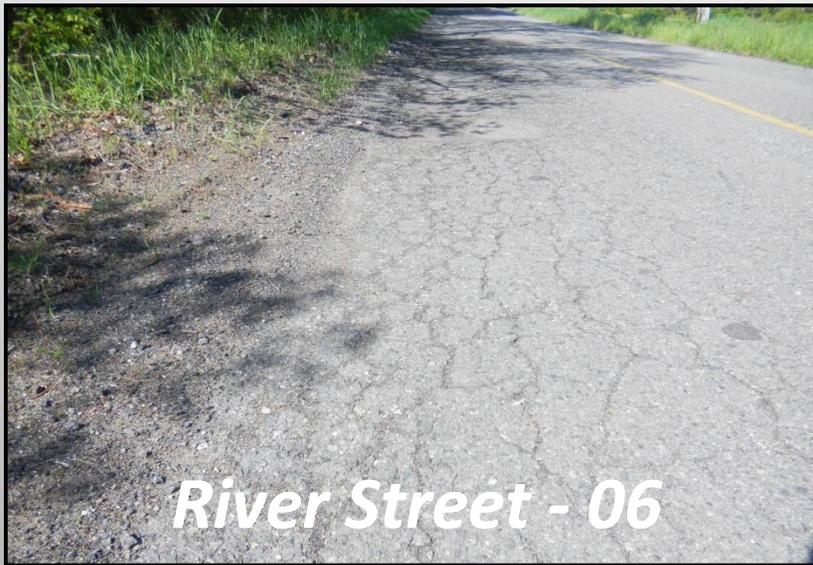
*RSR = 15*

*Grade = F*

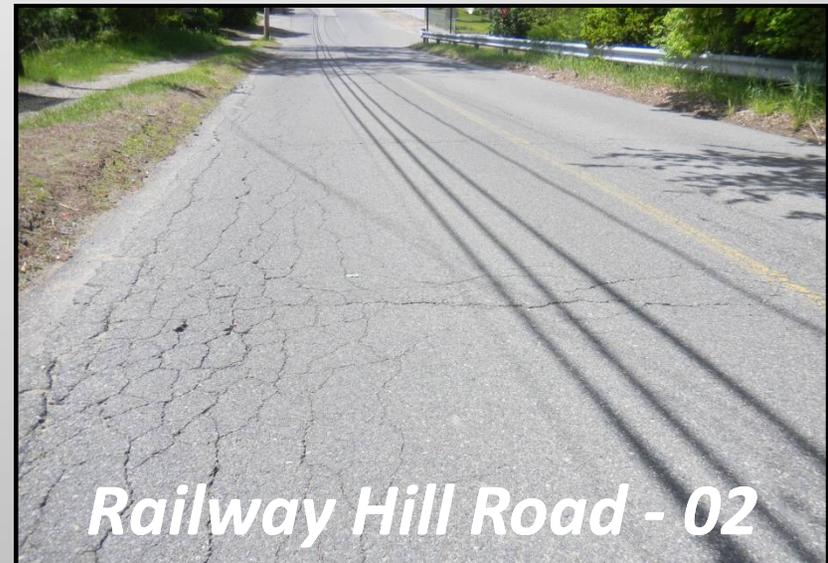
*RSR = 47*

*Grade = F*
